St Cuthbert Mayne Roof Project.

An update for the parishioners of St Cuthbert Mayne Parish, including St Peter's Bude and Our Lady of Victories, Callington. This relates solely to the church of St Cuthbert Mayne, Launceston.

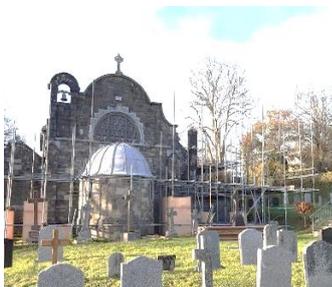
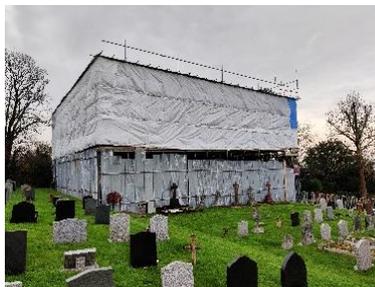
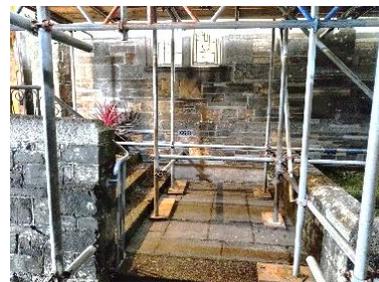
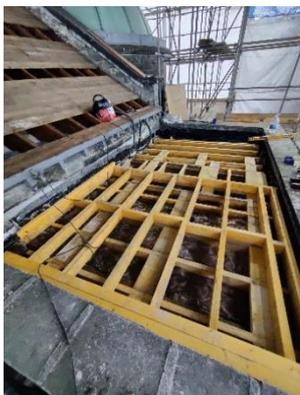
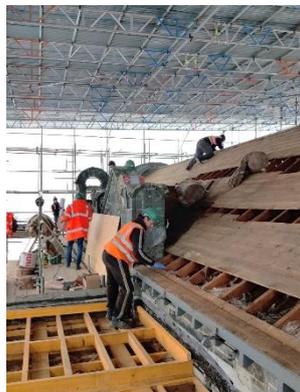
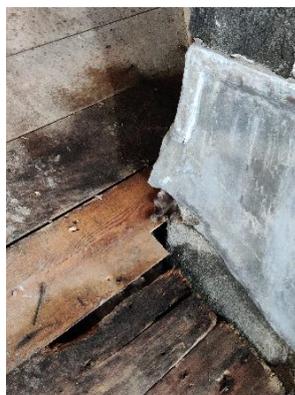
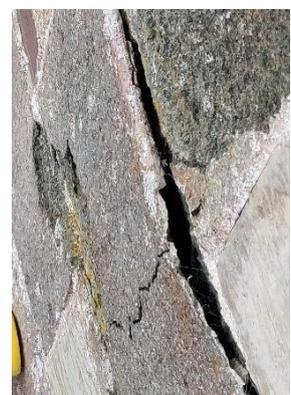
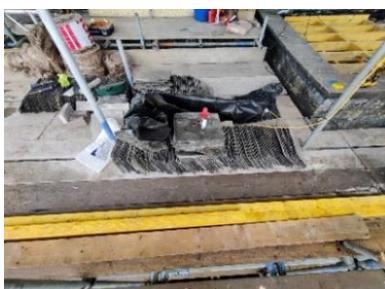
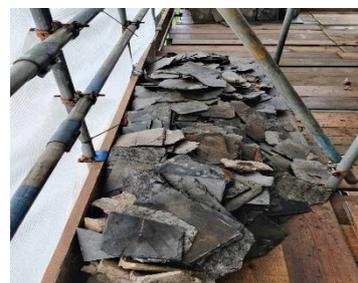
In late autumn 2020 a specification was made for the repair and put out to tender. **The contractor Ryearch were chosen** and started work in November. First the whole church was **enclosed in scaffolding** with a roof and sides. Then the slates were removed; the **wood supports were in places rotten and worm eaten**. These have been replaced, new felt and insulation added. We will re-use as many of the original slates as possible, but up to 2000 will need to be like-for-like replacements.

The stonework has **deteriorated badly in places**; new stone will be delivered later in the month and be carved to replace the worst sections. Not all the worn stone can be replaced due still to cost constraints. Finally, the slates will be reinstated, **new woodwork finished, guttering repaired/replaced** and so on.

We are keeping a **Photo Record of the works**; a few shots are included below. A fuller selection can be seen by [clicking this link](#).

This month **all the leadworks** will be replaced by specialist tradesmen and marked with security SmartWater.
